MARION CITY COUNCIL

GEOTECHNICAL STABILITY ANALYSIS REPORT

Lake George Dam Marion, Kentucky

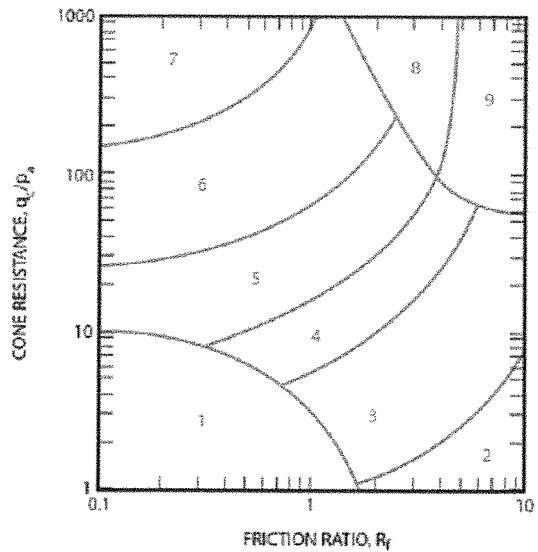
Non-normalized CPT Soil Behavior Type (SBT) chart

The estimated stratigraphic profiles included in the CPTu logs are based on relationships between q_t , f_s , R_f , and U_2 as shown graphically in the figure below.

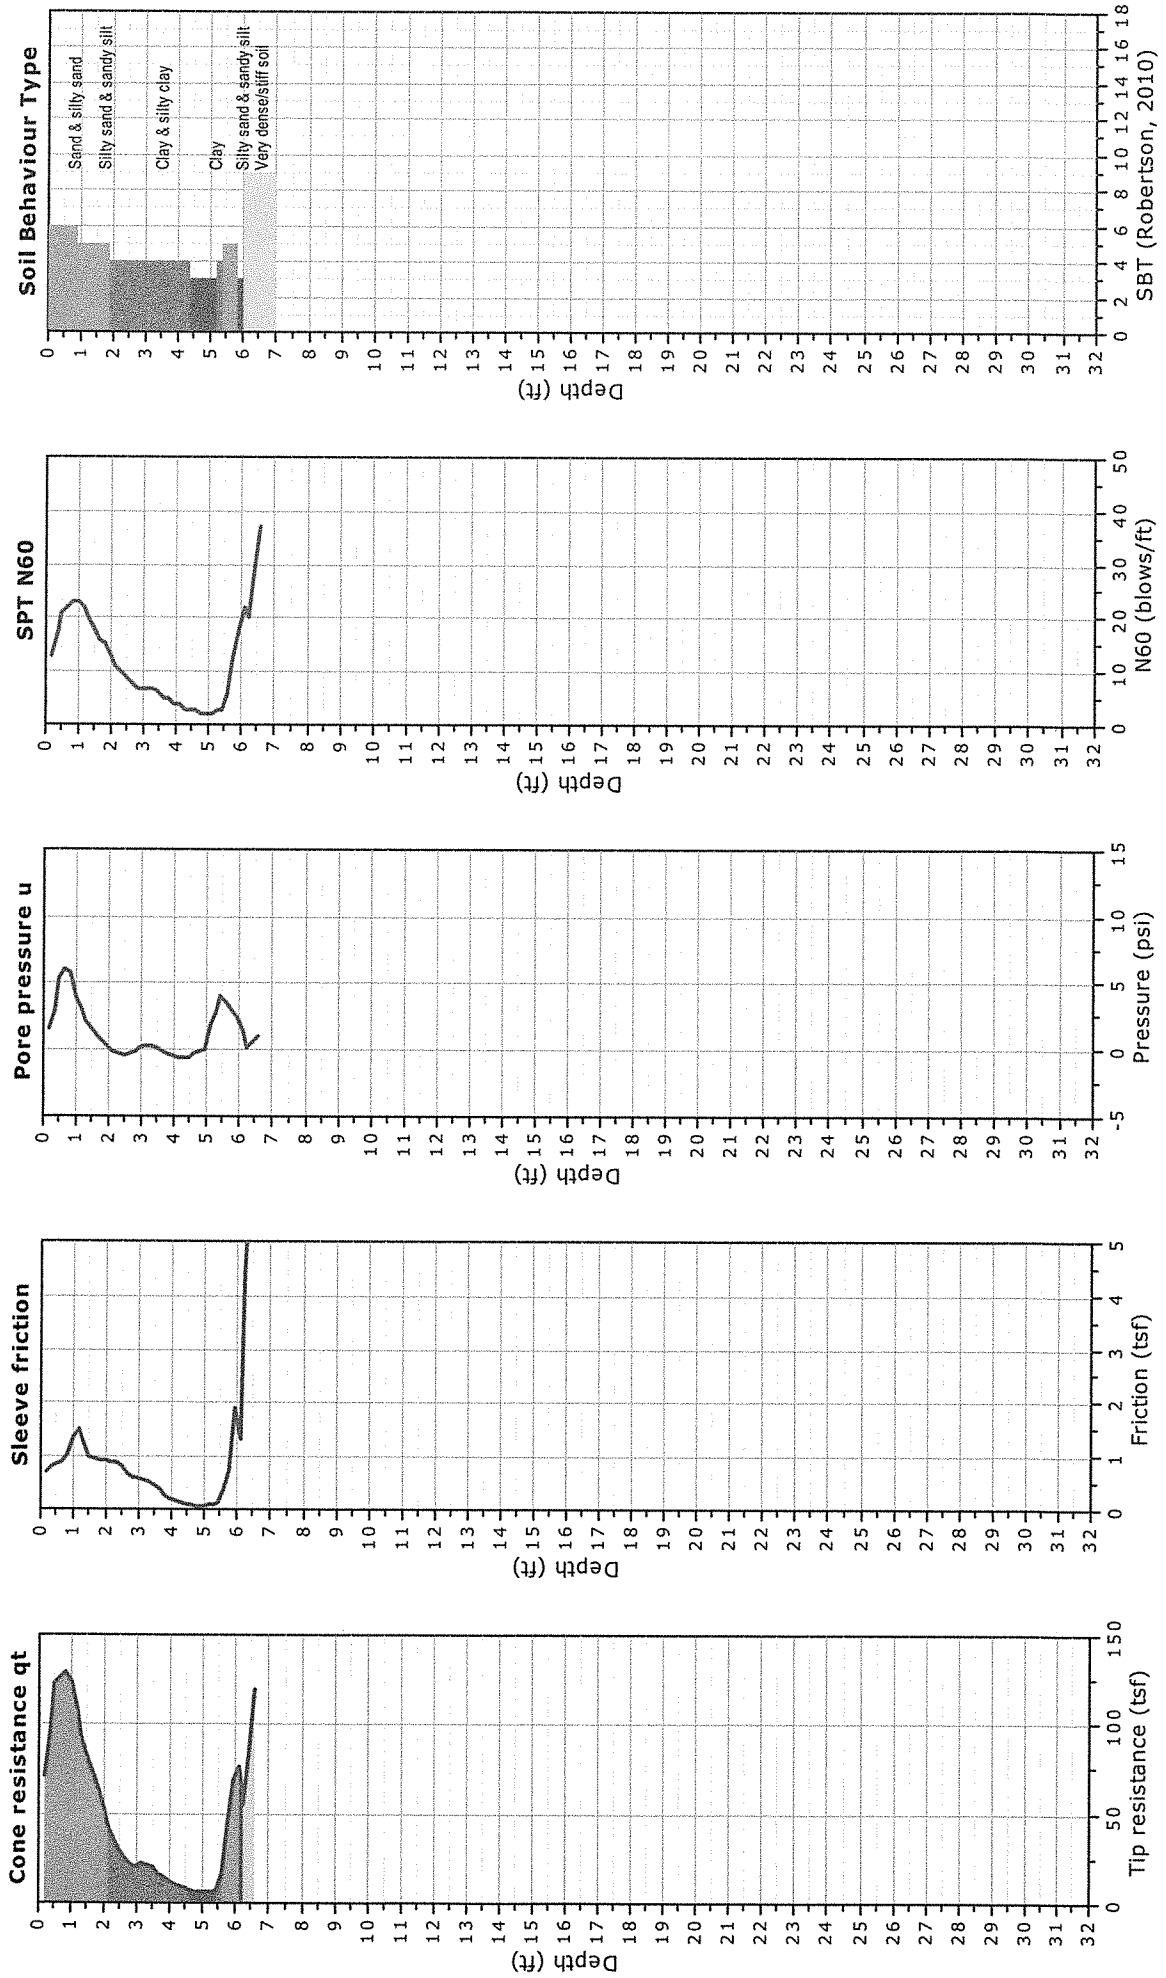
CPT: C-2
 Total depth: 6.56 ft, Date: 7/29/2022
 Surface Elevation: 577.00 ft

Project: 22231: Lake George Dam Emergency Repairs
Location: Marion, KY

CPTu soundings C-1 through C-3 were advanced near the downstream toe of the dam in the native foundation soils. Based on the results of the CPT soundings, the native soils consist of loose to dense sands and gravels and occasionally small amounts of cohesive sand and silt. The remaining soundings were advanced on the existing dam embankment and the CPTu soundings indicated the embankment soils consisted of predominately soft to medium stiff lean clay soils with occasional silty layers. Hand auger borings were advanced immediately adjacent to soundings C-5 and C-8 and encountered predominately lean clay soils and occasionally silt. Vane shear testing indicated in-situ undrained shear strength of the embankment soils ranging from 0.2 to greater than 4.8 kips per square foot (ksf). Each CPT sounding was advanced to the depth of cone refusal, which we anticipate occurred on bedrock. The depth and elevation of bedrock encountered at each boring is summarized in Table 2.1. No rock coring was performed for the project; however, we anticipate the bedrock consists of either limestone or sandstone.

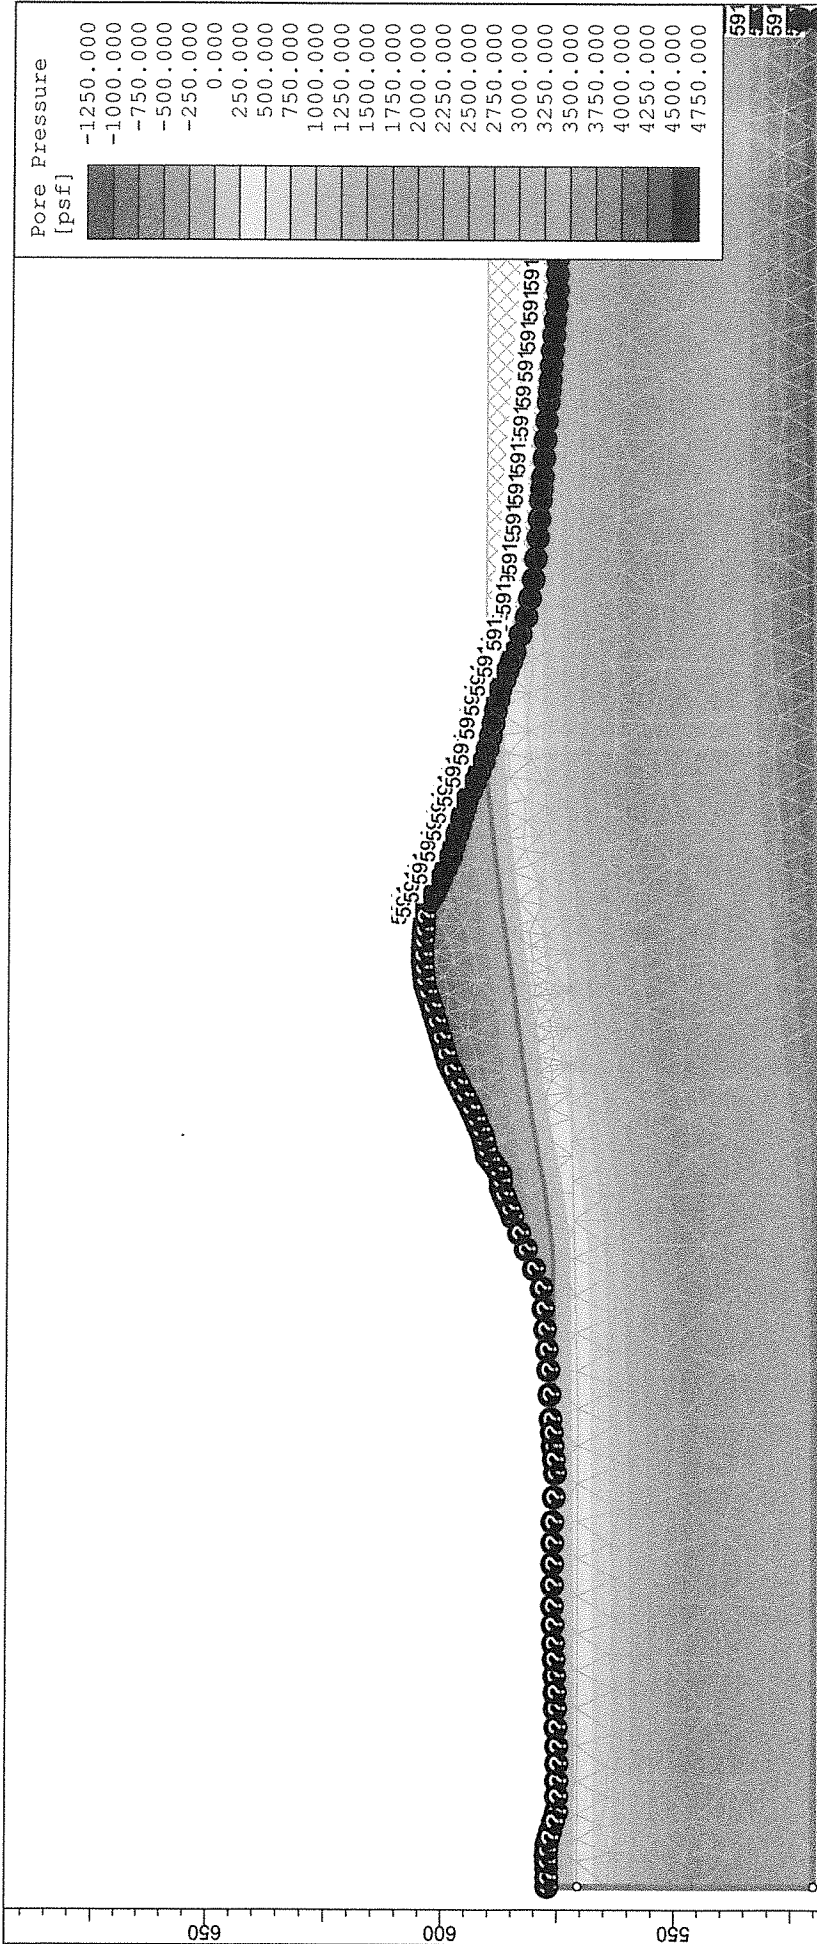
| Material Name | Color | Unit Weight (lbs/ft ³) | Strength Type | Cohesion (psf) | Phi (deg) |
|--|---|---|---|---|---|
| Embankment Fill (CL) | | 125 | Mohr-Coulomb | 100 | 26 |
| Foundation Soils - Silty Sands and Gravels | | 120 | Mohr-Coulomb | 50 | 30 |

Three analyses conditions were evaluated for the existing embankment geometry, as required by KDOW. The conditions analyzed were steady state seepage, rapid draw down and seismic. All analyses use long term strength parameters. The phreatic surface and pore pressures in the embankment determined in the seepage analysis were used in the slope stability analysis. For the seismic evaluation, the peak ground acceleration (PGA) from the design earthquake along with procedures for seismic slope stability outlined in Federal Highway Administration (FHWA) publication *FHWA-HI-99-012 Geotechnical Earthquake Engineering* were utilized. Soil parameters used in the analyses and the results of the analyses are shown on the output plots in Appendix E. A critical factor of safety (FOS) was calculated for each condition and then compared to the KDOW required FOS. The results of the analysis are shown in Table 3.1.

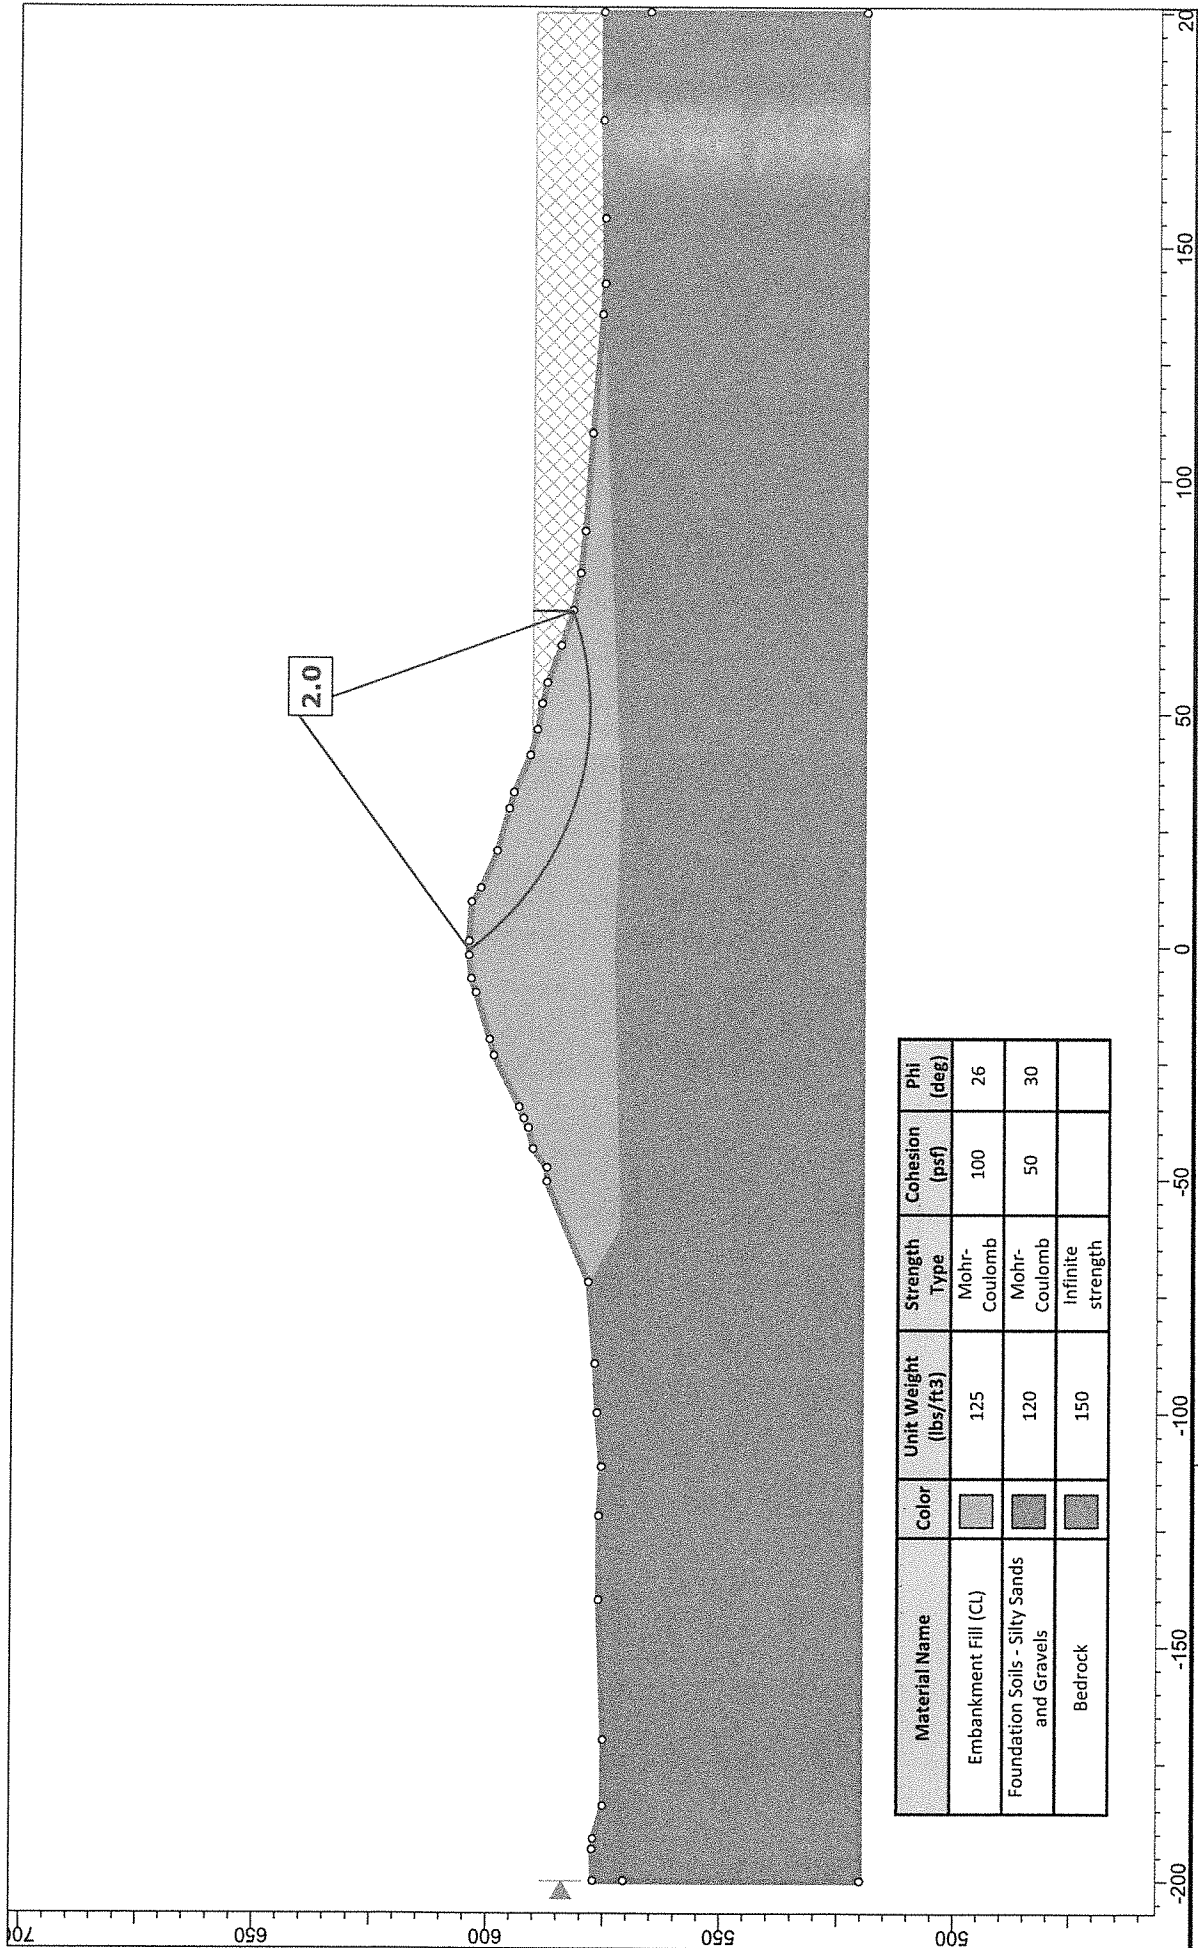
File Name STA 4+00.slm

| Material Name | Color | Unit Weight (lbs/ft ³) | Strength Type | Cohesion (psf) | Phi (deg) |
|--|---|---|---|---|---|
| Embankment Fill (CL) | | 125 | Mohr-Coulomb | 100 | 26 |
| Foundation Soils - Silty Sands and Gravels | | 120 | Mohr-Coulomb | 50 | 30 |

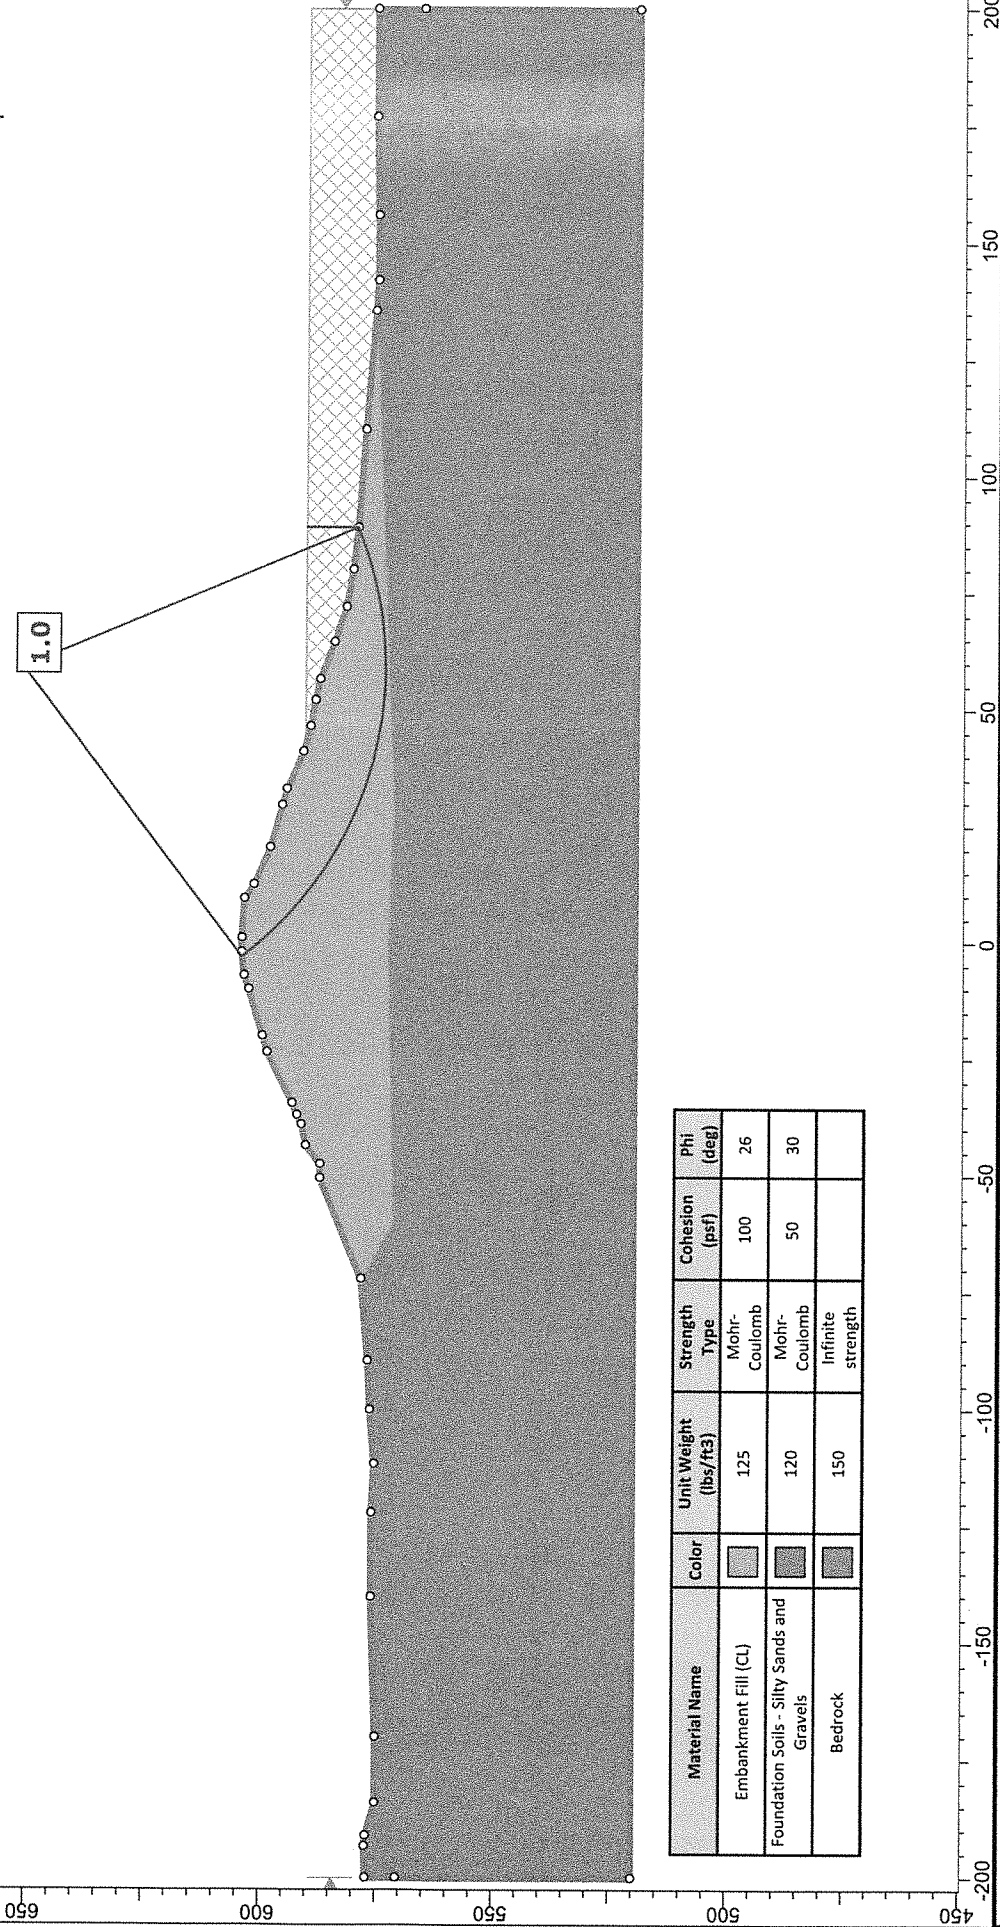
Scenario: Seismic
Company: BFW Engineering & Testing, Inc.
File Name: STA 4+00.slmtd

| Material Name | Color | Unit Weight (lbs/ft ³) | Strength Type | Cohesion (psf) | Phi (deg) |
|--|---|---|---|---|---|
| Embankment Fill (CL) | | 125 | Mohr-Coulomb | 100 | 26 |
| Foundation Soils - Silty Sands and Gravels | | 120 | Mohr-Coulomb | 50 | 30 |

Project: 22231 Lake George Dam Emergency Repairs
Group: Pool EI = 591
Drawn By: CLM
Date: 8/8/2022, 9:39:32 AM

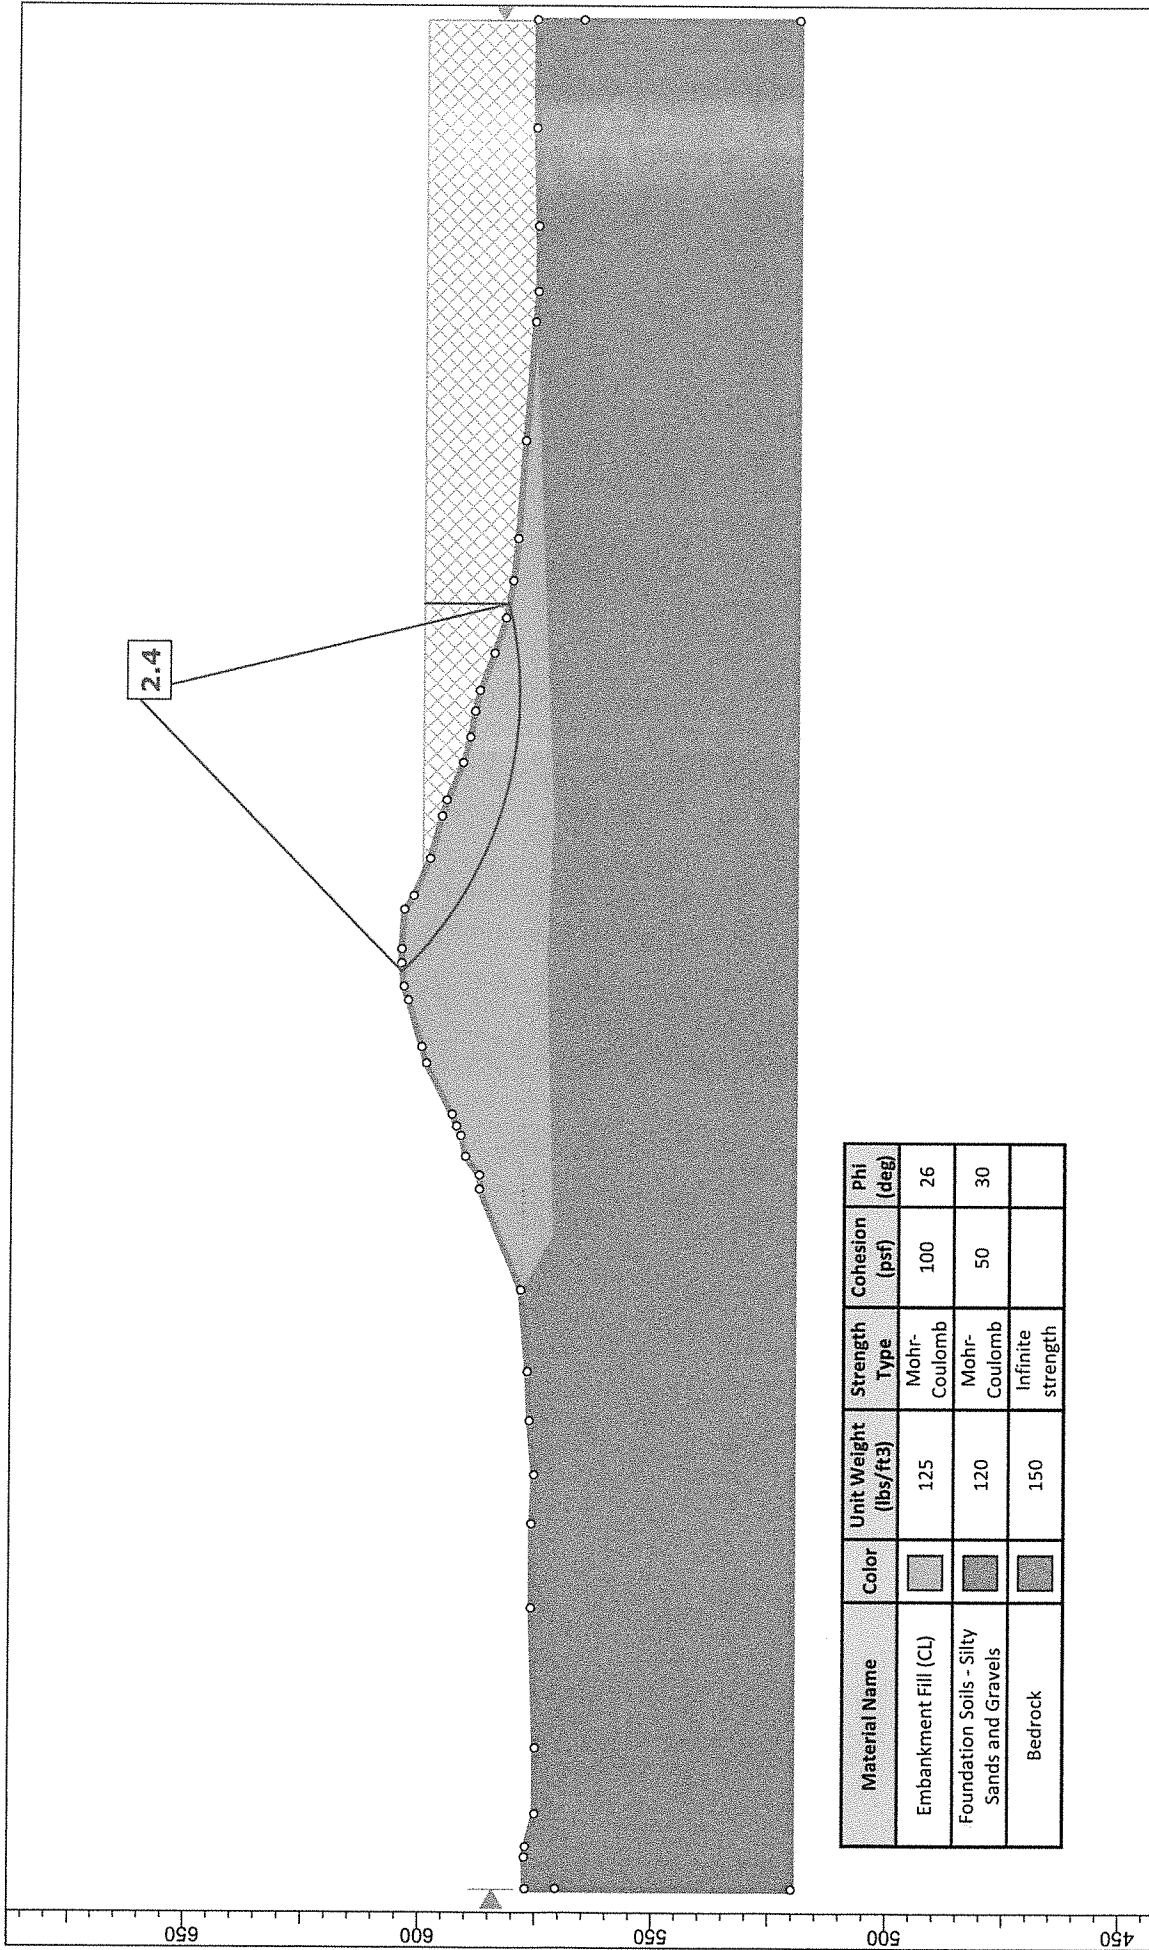
| 8/8/2022, 9:39:32 AM | | STA 4+00.slimd | |

| Material Name | Color | Unit Weight (lbs/ft ³) | Strength Type | Cohesion (psf) | Phi (deg) |
|--|---|---|---|---|---|
| Embankment Fill (CL) | [Light Gray Box] | 125 | Mohr-Coulomb | 100 | 26 |
| Foundation Soils - Silty Sands and Gravels | [Dark Gray Box] | 120 | Mohr-Coulomb | 50 | 30 |

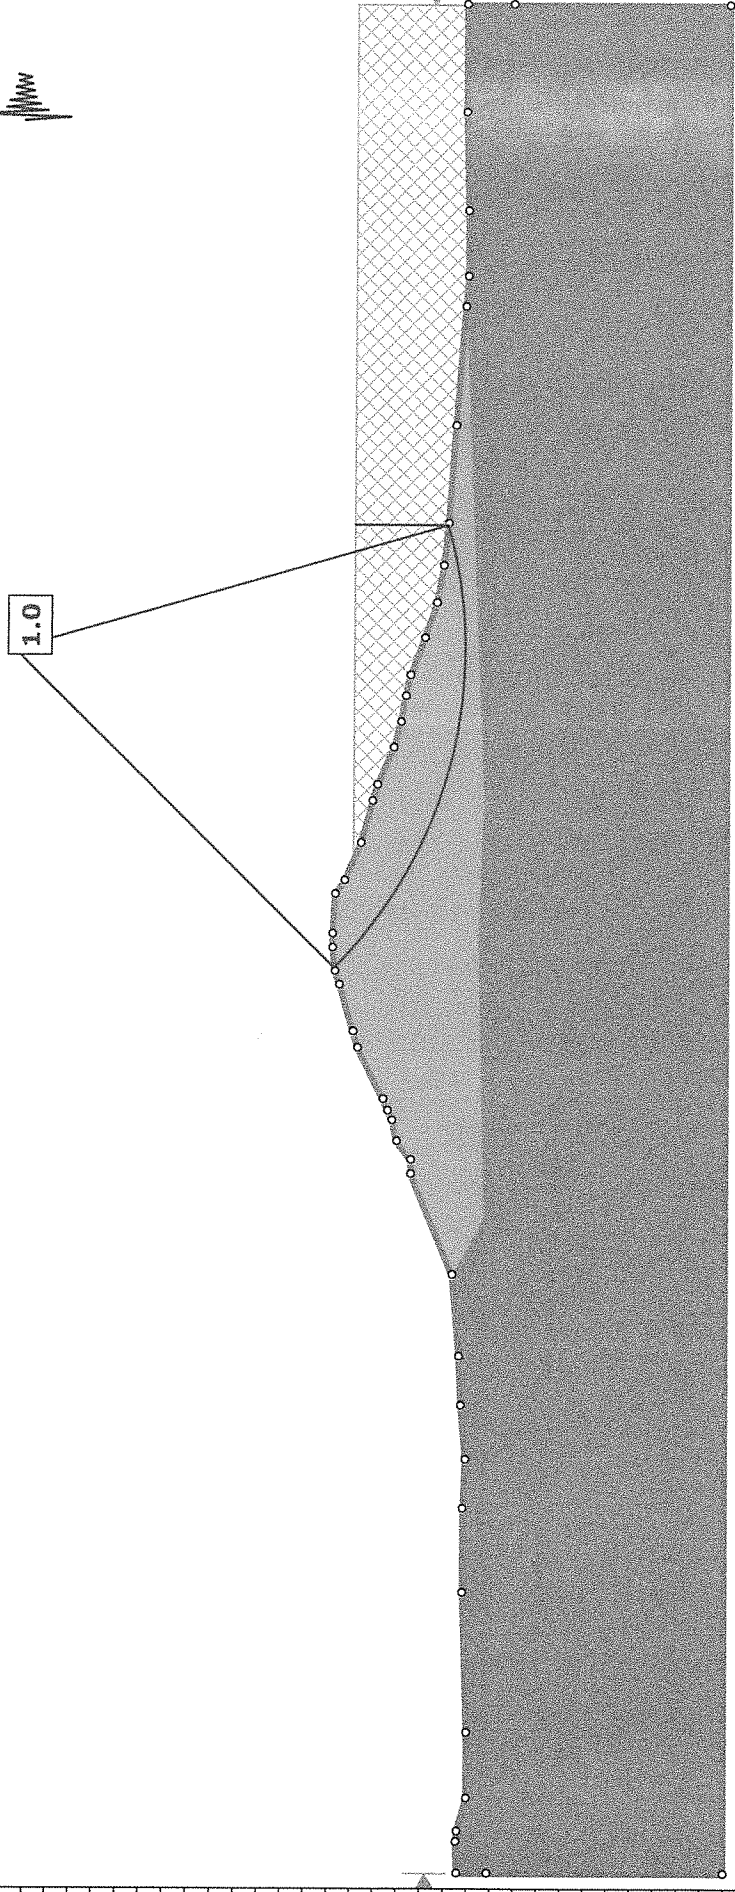
| Material Name | Color | Unit Weight (lbs/ft ³) | Strength Type | Cohesion (psf) | Phi (deg) |
|--|---|---|---|---|---|
| Embankment Fill (CL) | | 125 | Mohr-Coulomb | 100 | 26 |
| Foundation Soils - Silty Sands and Gravels | | 120 | Mohr-Coulomb | 50 | 30 |
